HO-944
"Oakland Farm"
1825 McKendree Road
Cooksville vicinity
Howard County, Maryland
Private
c. 1899

Maryland Inventory of Historic Properties Form

Inventory No. HO-944

historic "Oakland Farm"
other

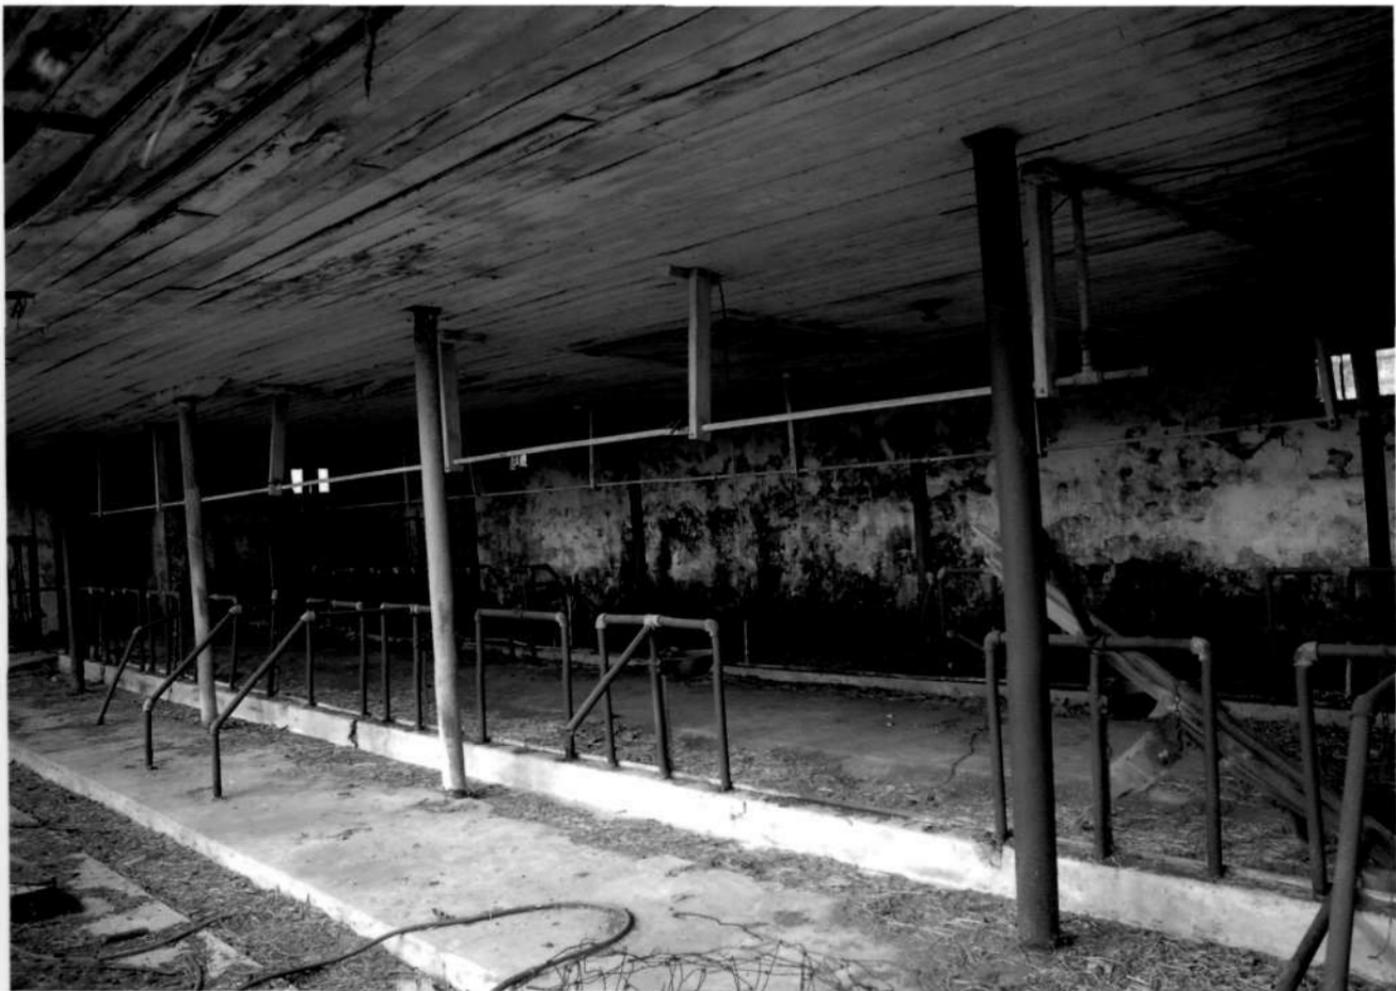
14/17

Barn Interior, lower story
View Northwest

The lower story is a modern milking parlor with a concrete floor that has troughs in it, two rows of steel stanchions that run east-west, and bead-board ceiling.

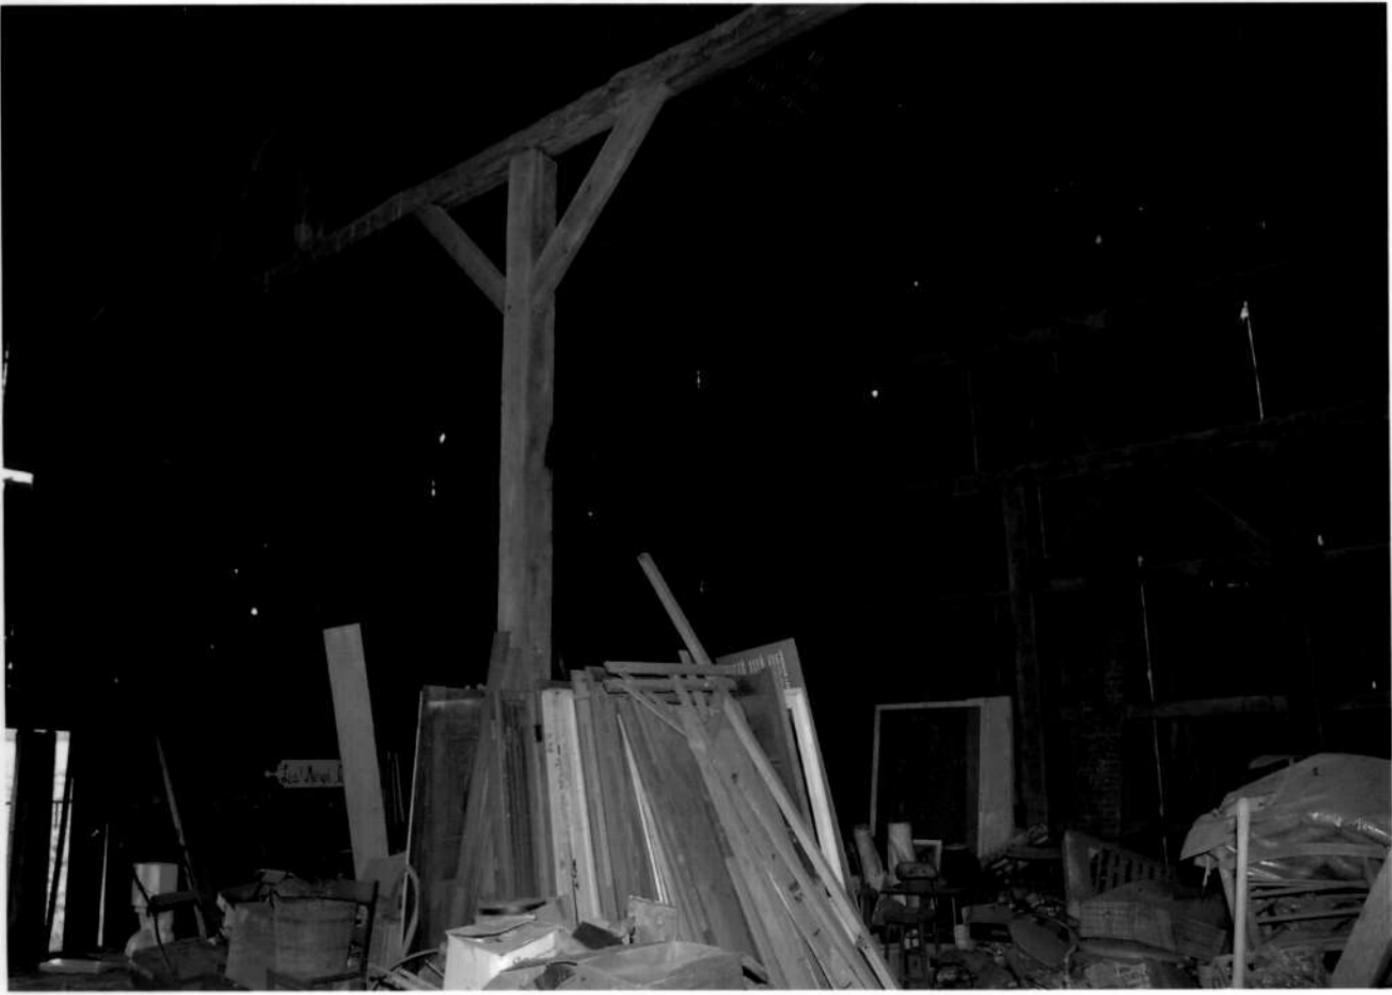
15/17

Barn interior, upper story, view
southwest

The upper story of the barn has a center threshing floor with a hay mow to each side. The barn was originally a smaller structure that was enlarged by adding onto the south end and raising the barn in height. The original frame is hewn, with sawn up-braces and the east and west ends have four posts with dropped girts. All of this framing is mortised and tenoned and pegged. Short posts were added on to the top of the girts with pieces of wood bolted across the joint to hold these short posts in place. Girts were then set on top of the short posts. The north plate for this addition appears to be reused and is probably the original south plate. It has empty mortises for missing braces. The original scarf joint was half-lapped, with beveled haunches and two face pegs. The original section has three horizontals between the bottom sill and the top plate, and these are sawn and mortised and tenoned and pegged. The barn has inner bents that must be completely new construction, though the posts are hewn and mortised and tenoned and pegged. These bents have a single center post with up-braces into dropped girts. There are queen posts on the girts, with a down-brace to the outside, and these could be reused purlin struts that were set up-right. These inner girts are circular-sawn, with waney edges. The rafters are sawn, with some reused ones that are hewn. The reused rafters had half-dovetailed lapped collar beams that were nailed. There are two joints on each rafter near each other, suggesting the possibility of scissor bracing, or even scissor trusses. There is no opening in the roof to give access to the cupola.

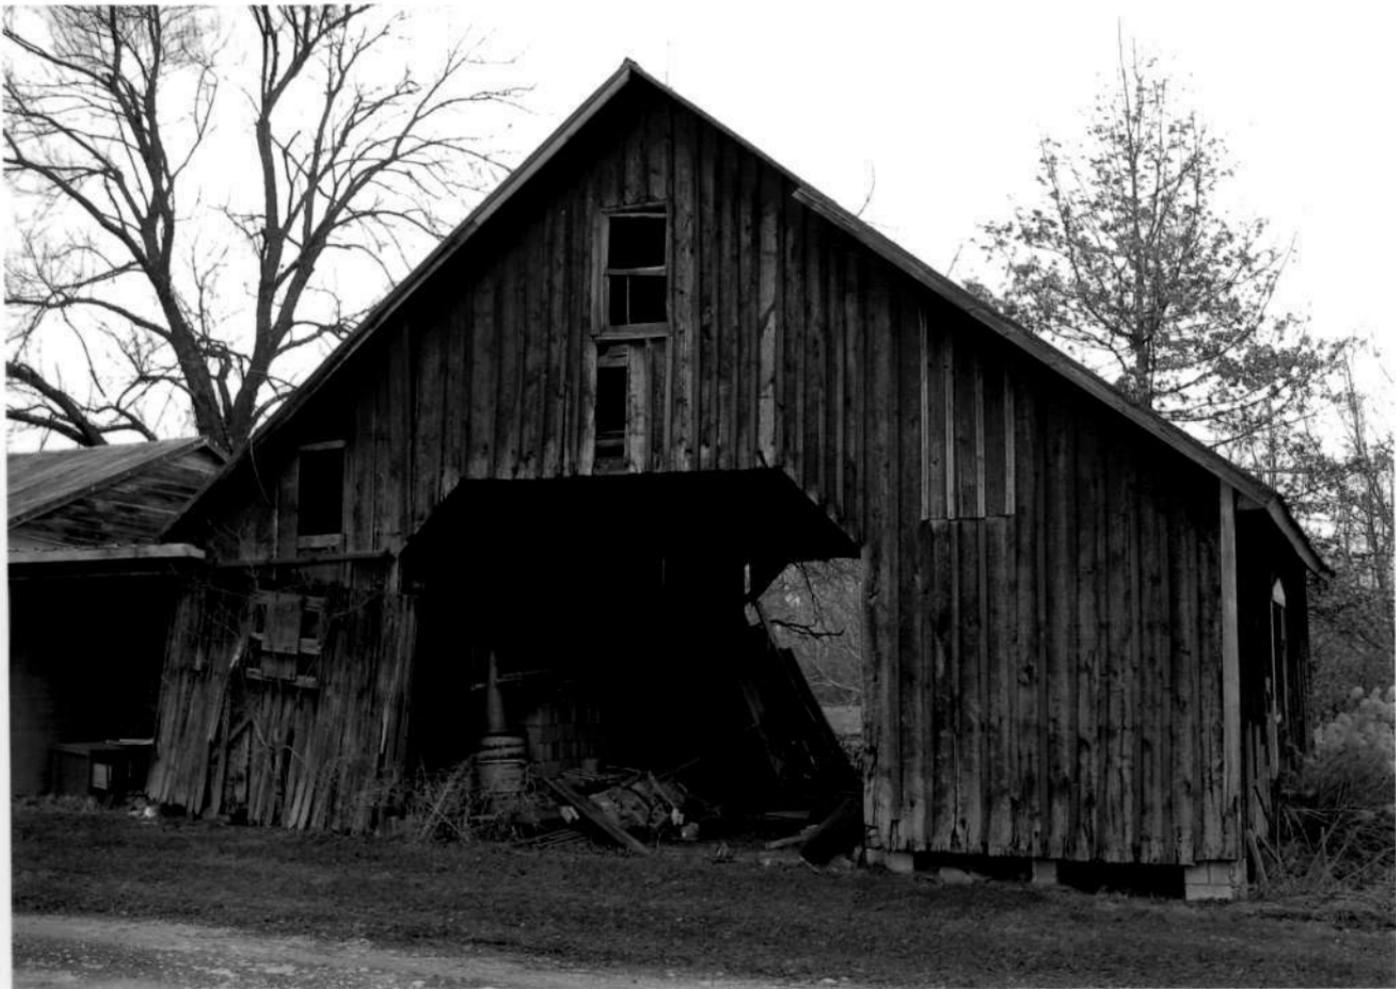
16/17

Wagon Shed, South Elevation

There is a wagon shed located about forty feet northwest of the barn. It is a one-story, one-bay by one-bay frame structure on CMU piers, with board-and-batten siding that is circular-sawn and fastened with both cut and wire nails. There is a gable roof with a north-south ridge and inverted-v-seam metal. The south elevation has one large opening in the center and the remains of a six-over-six sash in the gable end. The east elevation has a vertical-board door in the center, hung on butterfly hinges, with pedimented head-cut trim. The north elevation has a large opening in the center and a track for a door that hung on rollers. There is a six-over-six sash in the gable end. A CMU shed is attached to the west elevation. The interior of the wagon shed has vertical

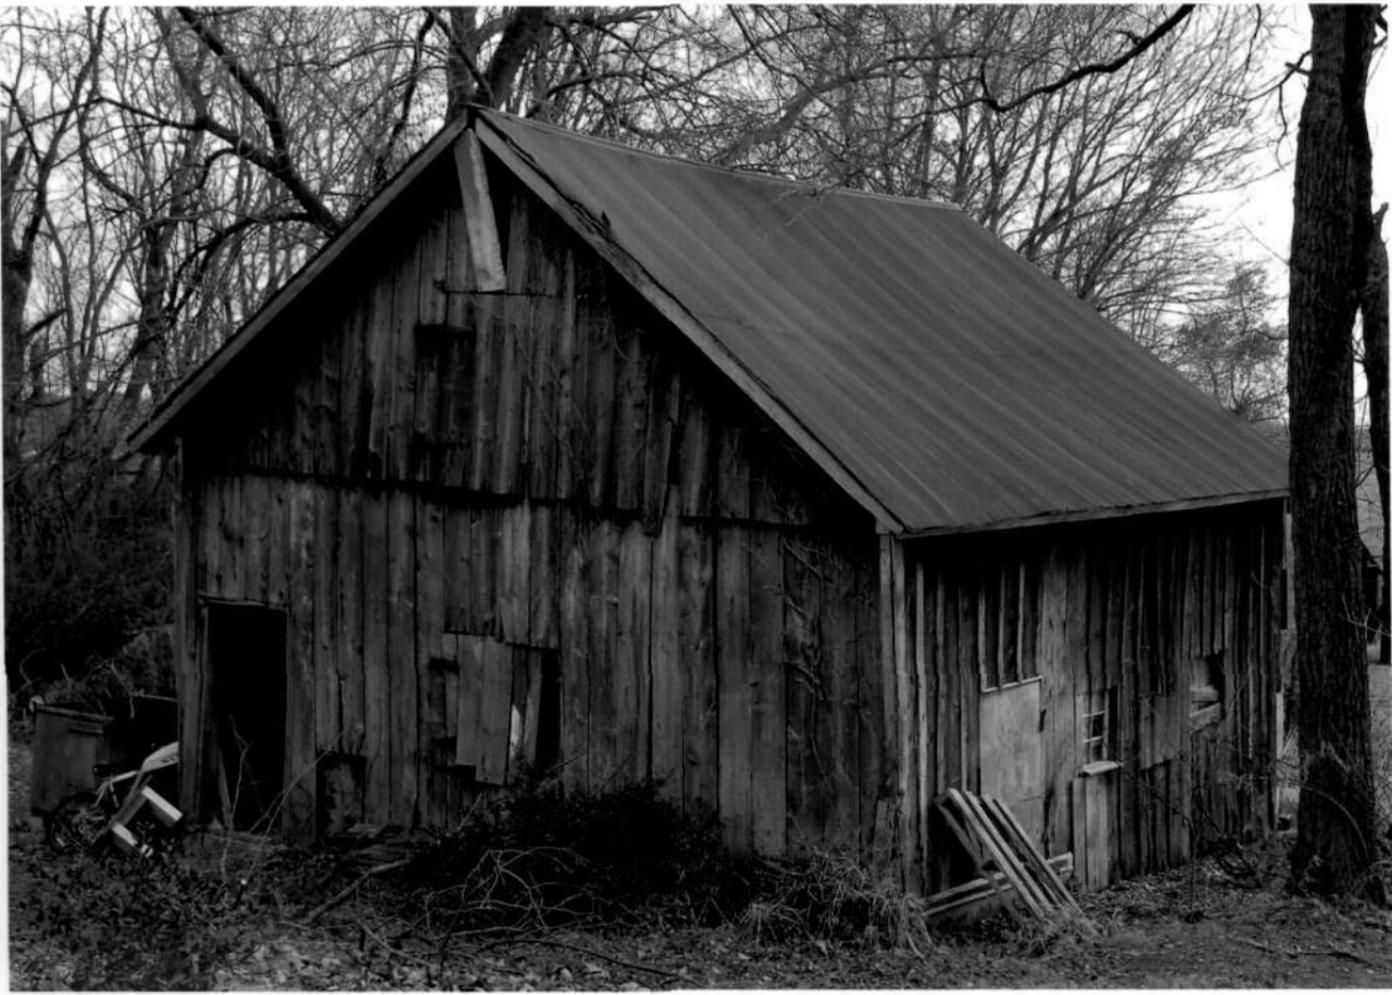
17/17

Outbuilding, North and West Elevations

About two hundred feet south of the house is a one-story, three-bay by three-bay outbuilding that has a CMU foundation, frame walls with board-and-batten siding on the west and vertical boards on the north, and a gable roof with corrugated metal and a north-south ridge. The building has open eaves. The north elevation has a doorway to the east and a hatch in the center. The west elevation has a doorway set to the north and a six-light sash in the center and south bays. The south elevation is missing some siding where the frame has been repaired. The east elevation has a hole cut in the center. The building has a dirt floor and a circular-sawn frame that is mortised and tenoned and pegged. There are circular-sawn 2 by 4 rafters that are mitered by the ridge. A partition wall of horizontal boards divides the center into two sections, with the wall running north-south.
